Manhole Inspection Summary

Manhole # S43WW_006MH

Insp Date: **2/16/07 9:20 AM**

Location Address: **1601 29TH ST**

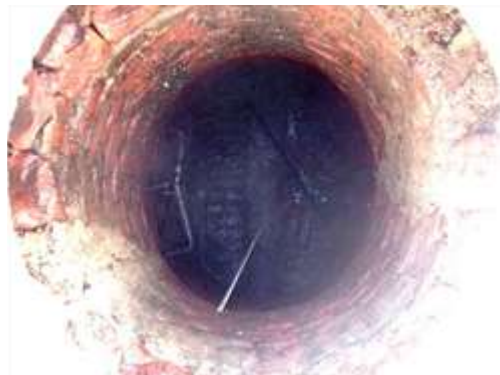
Top View

Corroded and missing steps. Evidence of surcharge - Bench debris. Adjustment and Corbel infiltration.

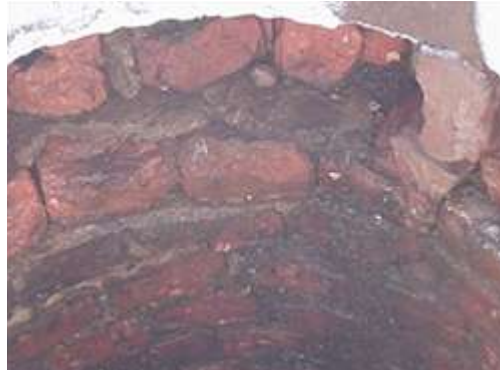
Defect

Frame leaks. Adjustment deterioration and infiltration.

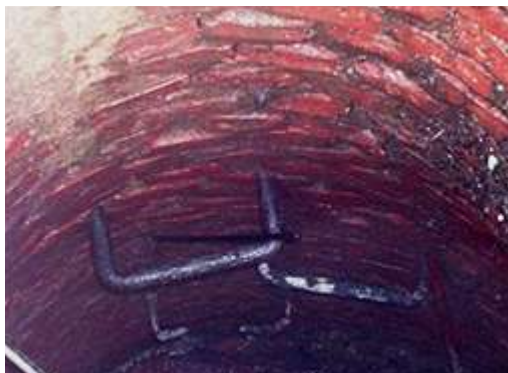
Defect

Adjustment, Corbel and Barrel infiltration.

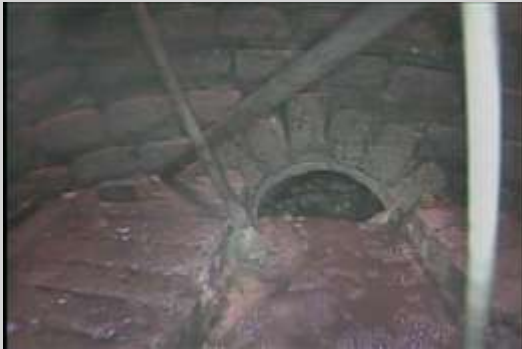
8 in. Circular Gravity Sewer Pipe Out @ 12 O'Clock

Barrel deterioration and infiltration. Bench deterioration.

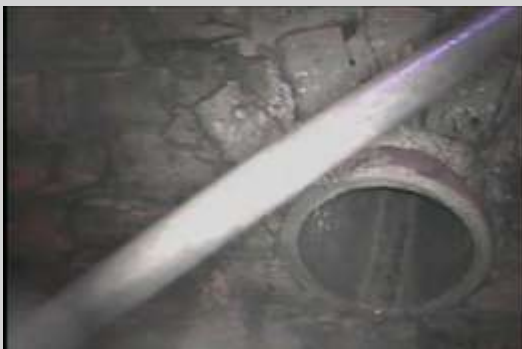
6 in. Circular Gravity Sewer Pipe In @ 3 O'Clock

Barrel deterioration.

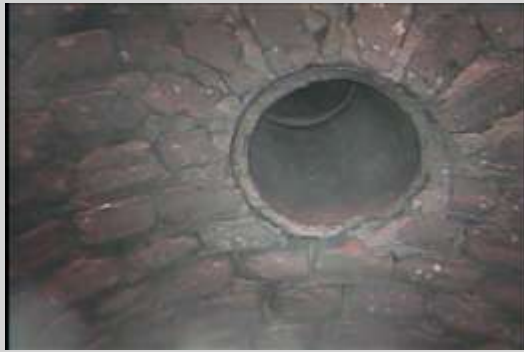
Pipe In @ 6 O'Clock

Barrel deterioration and infiltration.

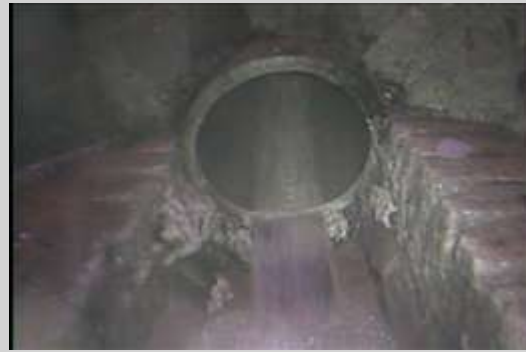
Drop In @ 6 O'Clock

Channel deterioration.
